Manhole Inspection Summary

Manhole # S25S__001MH

Insp Date: **6/2/08 1:41 PM**

Location Address: **1500 Wicomico St**

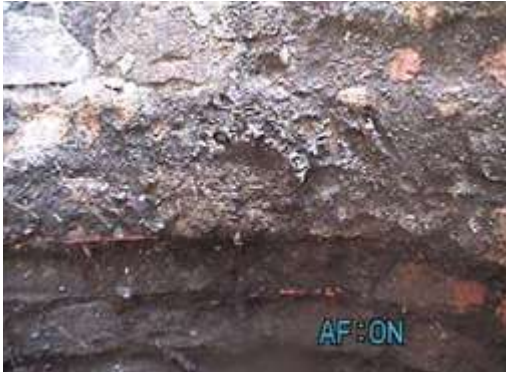
Defect 3

☒ **Evidence Of Surcharge** Depth: **6** (ft.) ☐ Active Surcharge Present

signs of surcharge corbel area

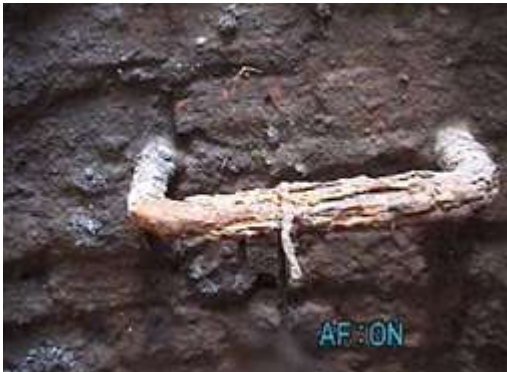
Defect 1

Count: **2** Missing: **0** ☒ **Corroded**

corroded rungs

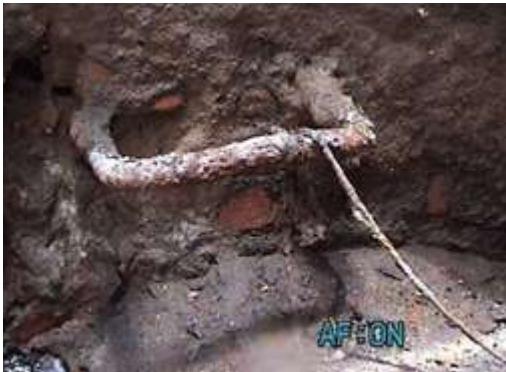
signs of surcharge

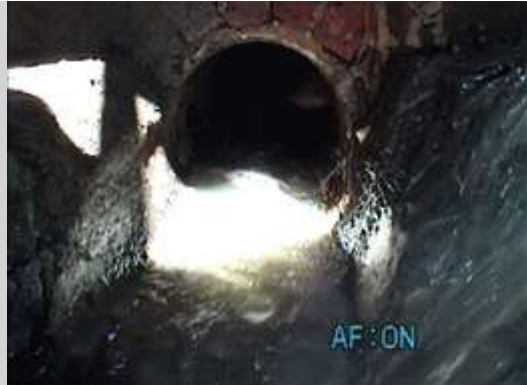
12 O'Clock Outflow

8 in. Circular Gravity Sewer
Pipe Out @ 12 O'Clock

Pipe Height: **7.2** (in.) Rod and Bar (Angled)
Pipe Material: **Clay** ☐ Pipe Lined
Invert Depth: **6.62** (ft.) Flow Characteristics: **Fast**
Deposits: ☒ None ☐ Mud ☐ ~~Gravy~~ ☐ Debris ☐ Grease
Silt Depth: **0** (in.) Deposits Extent:
Infiltration: **None** Pipe Seal Cond: **Unknown**

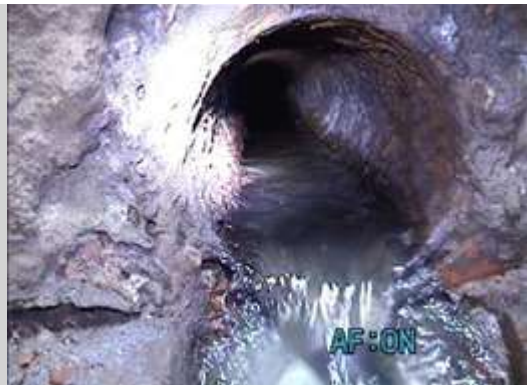
3 O'Clock Inflow

8 in. Circular Gravity Sewer
Pipe In @ 3 O'Clock

Pipe Height: **7.2** (in.) Rod and Bar (Angled)
Pipe Material: **Clay** ☐ Pipe Lined
Invert Depth: **5.03** (ft.) Flow Characteristics: **Fast**
Deposits: ☐ None ☒ Mud ☒ ~~Gravy~~ ☐ Debris ☐ Grease
Silt Depth: **0.5** (in.) Deposits Extent: **Light**
Infiltration: **None** Pipe Seal Cond: **Unknown**

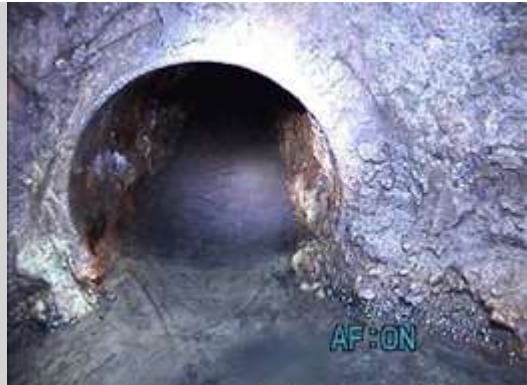
7 O'Clock Inflow

10 in. Circular Gravity Sewer
Pipe In @ 7 O'Clock

Deposits: ☐ None ☐ Mud ☒ **Sludge** ☐ Debris ☐ Grease

Silt Depth: **3** (in.) Deposits Extent: **Medium**
